# Case Study

## Curtain Grouting Calgary Transit

## Project: Curtain Grouting

**Location of Project:** CP Tunnel, downtown Calgary, Alberta

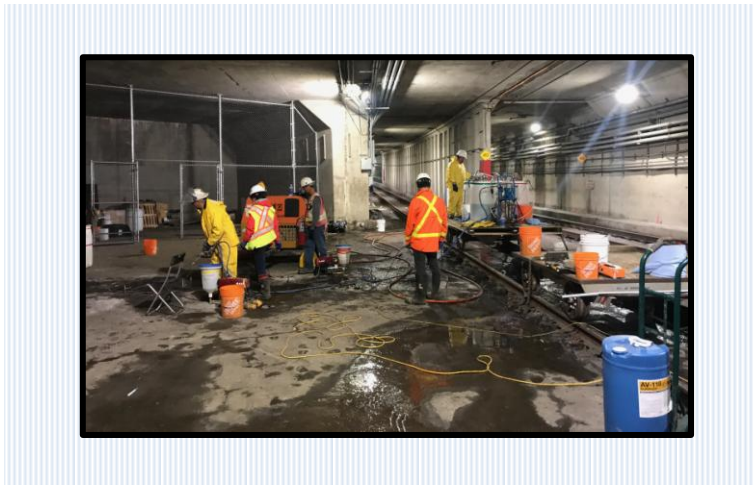
**Description of Application:** Stray Cat was engaged by Graham Construction to assist in solving persistent groundwater infiltration issues inside a tunnel in Calgary Transit's light rail transit (C-Train) network. Working with ECO Grouting Specialists Inc., who designed and supervised the grouting program, we successfully injected an acrylamide grout into seven tunnel joints over two separate weekends during the summer of 2017. First, holes were drilled in the concrete walls and floor of the tunnel. Certain holes were drilled at a ~45 degree angle, which were designed to contact the tunnel joint, in order to inject polyurethane to seal the joint prior to injecting acrylamide grout. Other holes were drilled at a perpendicular 90 degree angle through the floor and walls into the soil/bedrock beneath, which were up to 5 feet deep in the floor sections. The 45-degree holes were flushed with a phosphoric acid/water solution to clean out any debris, and then injected with a polyurethane grout to seal the joints. Next, the 90 degree holes were injected with the acrylamide grout, which has the same viscosity as water and can permeate anywhere water travels before curing as a gel, forming an effective and long-lasting water barrier.

**Condition of Structure:** Leaking water in joints between concrete tunnel sections

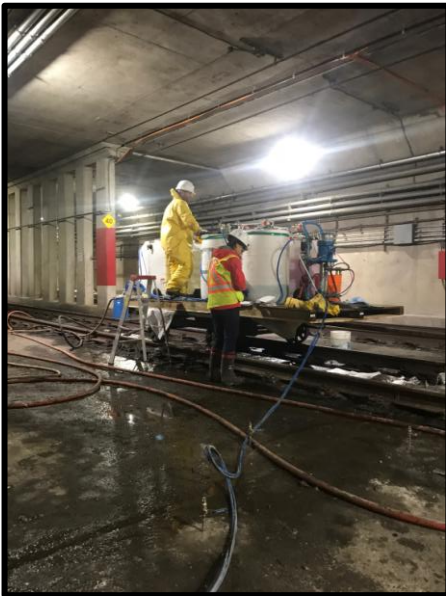
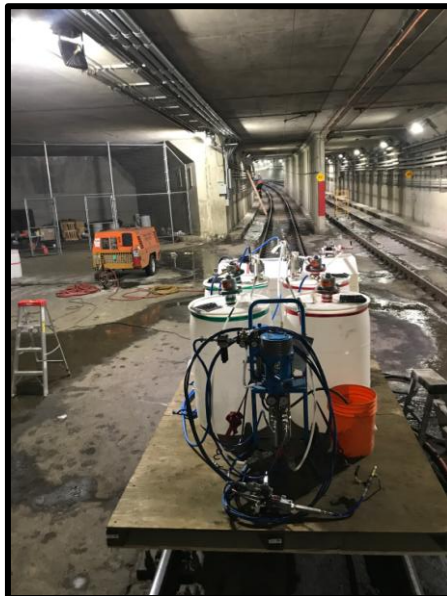
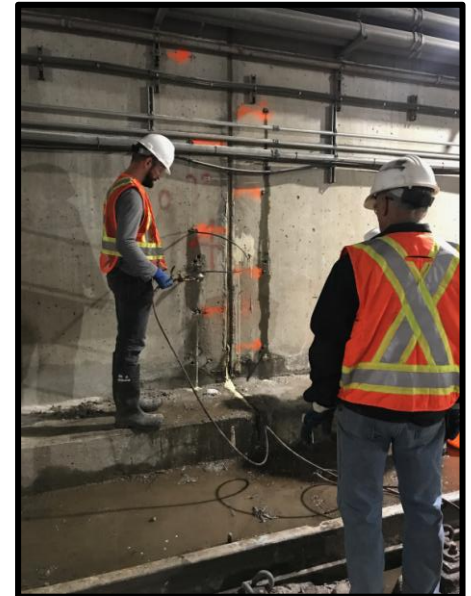
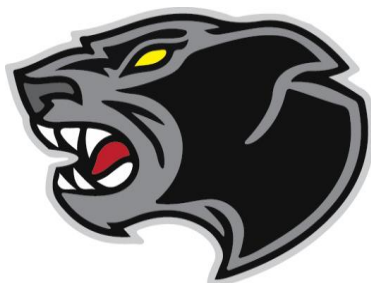
**QA/QC Tests Performed:** Prior to commencing acrylamide injection, the grout plant was tested with water to ensure that there were no leaks in the system and that the 2-component acrylamide injection pump was accurately injecting the A and B components of the acrylamide-based grout at a ratio of 1:1. Tests of the grout mixture were taken throughout the injection program to ensure that proper cure times were being achieved.
