Case Study

Spray in Liner Spectra Energy

Project: Spray in Liner

Location of project: Midwinter Gas Processing Facility, 300 KM's NE of Fort Nelson, British Columbia.

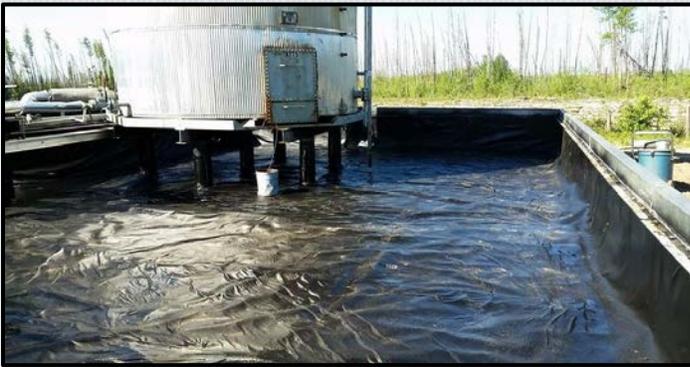
Description of Application: Substrate was uneven compacted dirt with a polyethylene liner that had failed. Stray Cat cleaned all penetrations and prepared the steel before any coatings were applied. We removed pile boots that had come apart from weld seams; steel preparation was done with a bristle blaster to achieve a near white profile of approximately 3 mils. Geo-textile fabric was laid and all walls and pilings were coated and encapsulated to create a seamless monolithic liner. Polyurea's ability to flex and stretch addressed the underlying cause of damage to the existing liner, which was due to shifting of the ground because of thermal cycling in the extreme climate conditions of northern Canada.

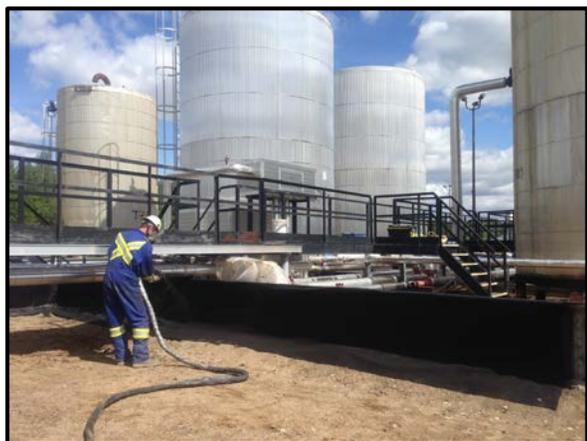
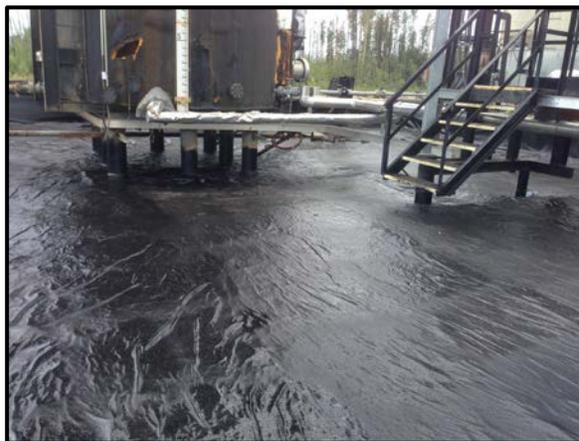
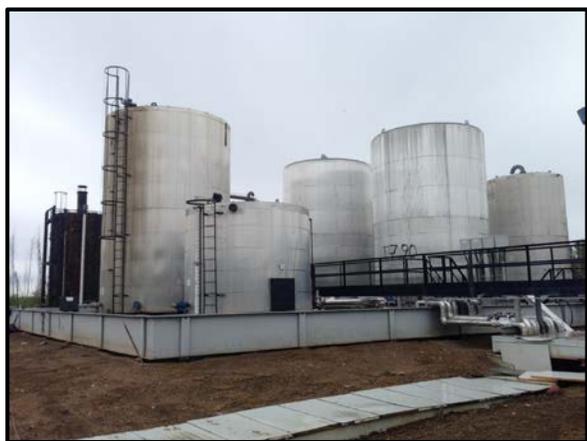
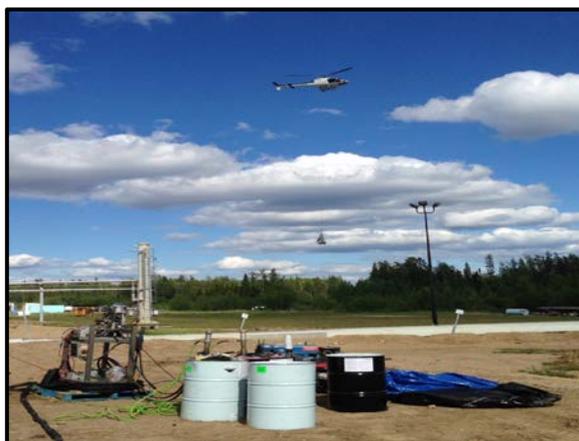
Type of Structure: Failed polyethylene liner retrofit for secondary containment for (4) separate containment areas for condensate tanks. Approximately 200 pilings and penetrations through liner.

Condition of Structure: Uneven ground with puddles, new steel containment system, old rusty and contaminated steel pilings, failed polyethylene liner
