Case Study

Spray in Liner CNRL

Project: *Spray in Liner*

Location of project: Wembley Field Facility, 50 KM's North of Grande Prairie, Alberta.

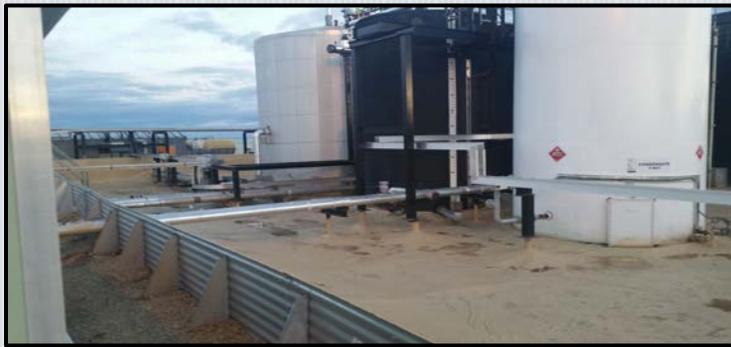
Description of Application: The substrate was uneven compacted dirt with a failed polyurethane liner. Stray Cat cleaned all penetrations and prepared the steel before any coatings were applied using 20/40 glass grit. We removed pile boots that had all came apart from weld seams, geo-textile fabric was laid, and all walls and pilings were coated and encapsulated to create a seamless monolithic liner.

Type of Structure: Failed polyethylene liner retrofit for secondary containment for condensate tanks. Approximately 150 pilings and penetrations through liner.
