Case Study

Spray in Liner Meritage Midstream

Project: Spray in Liner

Location of project: Patterson Creek Facility, 75 KM SE of Grande Prairie, Alberta

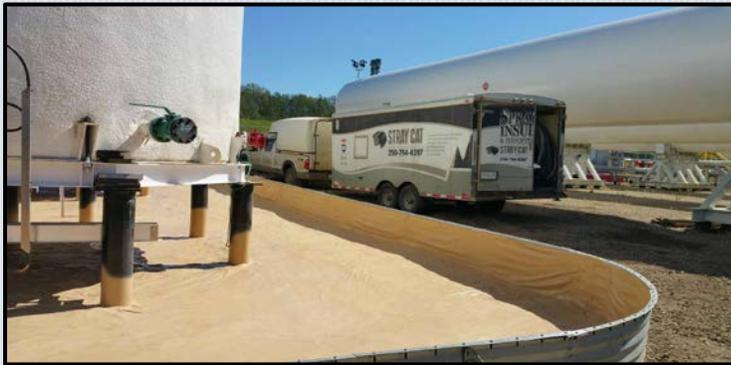
Description of Application: Stray Cat supplied and built a zero ground disturbance steel containment system and applied a geotextile/polyurea liner. The substrate was uneven compacted dirt; Stray Cat laid out sand and raked to smoothen the ground, then laid out non-woven geotextile and coated with polyurea. All walls of the containment system were covered with geotextile and coated and clamped on top of the walls with a top cap. All pilings were blasted to a white finish or Nace #1/SSPC-SP5, then coated 1 foot from ground floor.

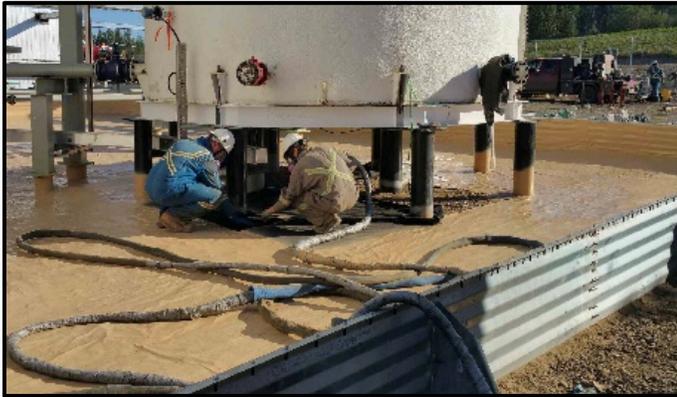
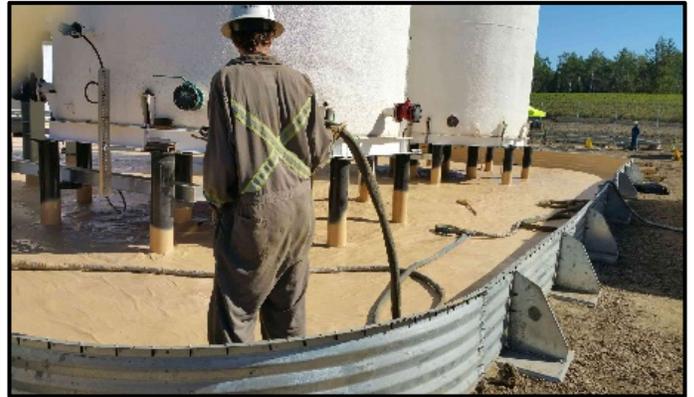
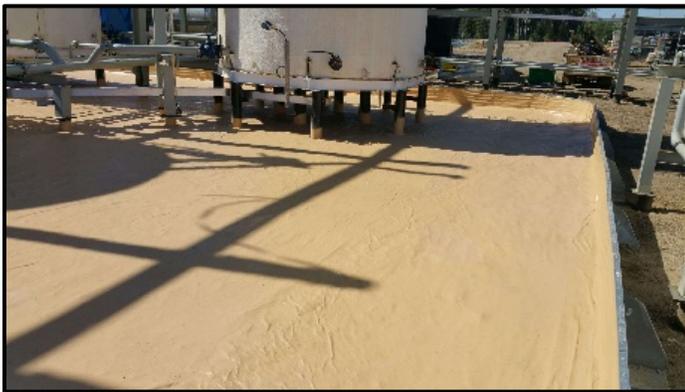
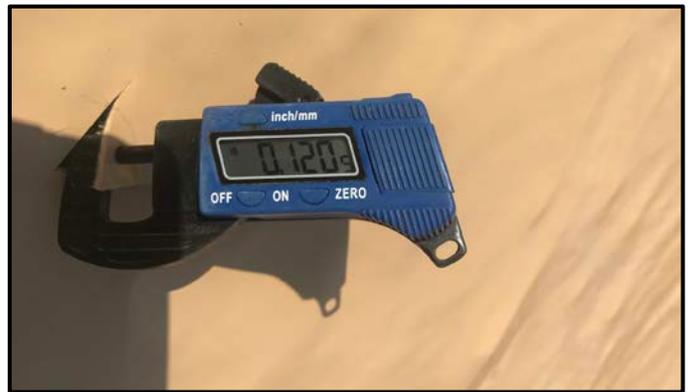
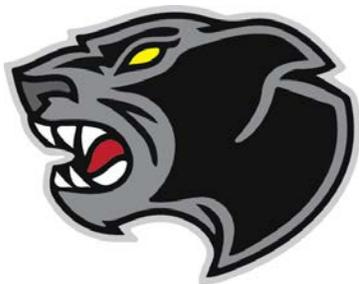
Type of Structure: Secondary containment for (4) 750 bbl tanks, 60 pilings

Condition of Structure: Uneven ground with puddles, new steel containment system, Newly pounded pilings with rust.
